City of Baltimore Wet Smoke and Dyed	Page 1 of 2	
Sewershed: Gwynns Falls	Company: Savin	Date: 9/22/2009
Test to be performed:  Smoke Dyed Water X	Ground Condition:  Dry ✓ Damp ☐ Wet ☐	Supervisor: JAW
Manhole_ID: S06I007MH	Test ID: <u>D1032-007009</u>	Notification Made: NA (Residents, Fire, 311)

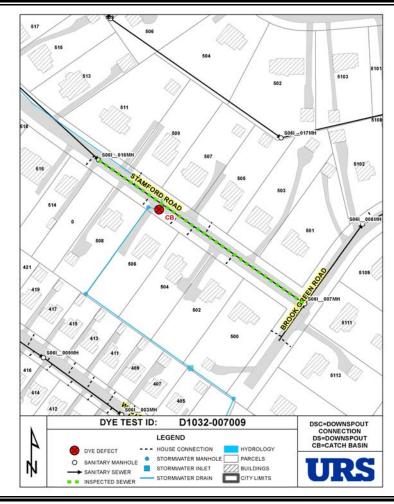
Field Sketch: Show all manholes with Numbers, Blower Placement Locations, Sandbag or Isolation Locations, Street Names, Building Addresses and Locations, Defect Locations and Photo Numbers.

Defect Loc	Obs_ClockFrom	Obs_ClockTo	Observation	Obs_Remarks
0			Manhole	S06I016MH
0			Start of Survey	
0			Water Level	
141.6000061	09		Tap Factory Active	
141.6000061			Dye Test Visible	DYE SEEN IN TAP
146.6000061			Dye Test Visible	DYE SEEN AT JOINT
149.6000061			Dye Test Visible	DYE SEEN AT JOINT
152.8000031			Dye Test Visible	DYE SEEN AT JOINT
155.8000031			Dye Test Visible	DYE SEEN AT JOINT
158.8999939			Dye Test Visible	DYE SEEN AT JOINT
188.6999969			Abandoned Survey	DYE TEST IS COMPLETE
